QUALITY REQUIREMENTS FOR PV POWER PLANTS FROM PLANING TO OPERATION LESSONS LEARNT ON TURKISH MARKET

Klaus Kiefer & Andreas Steinhueser

Fraunhofer-Institut für Solare Energiesysteme ISE

EMO Conference Izmir, October 17th, 2019

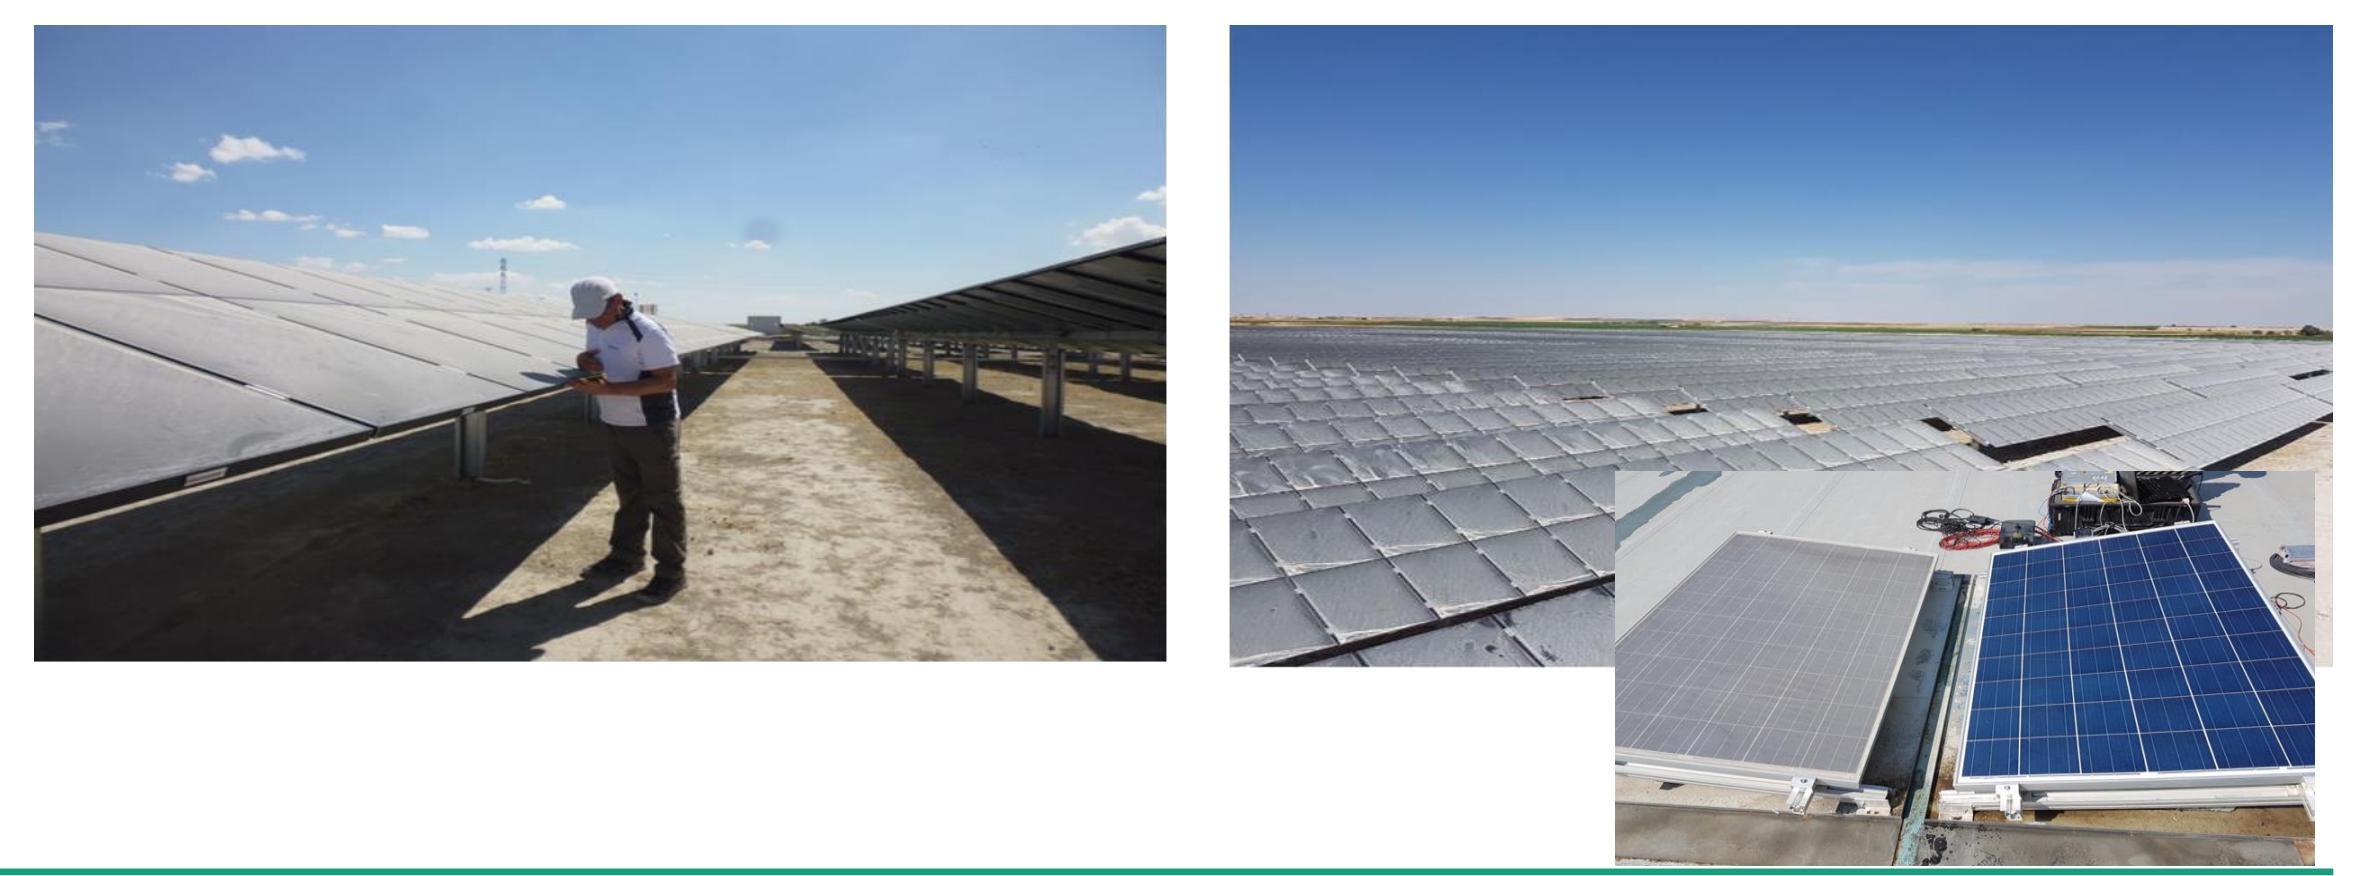
Locations with strong dust generation in the environment of animal food production

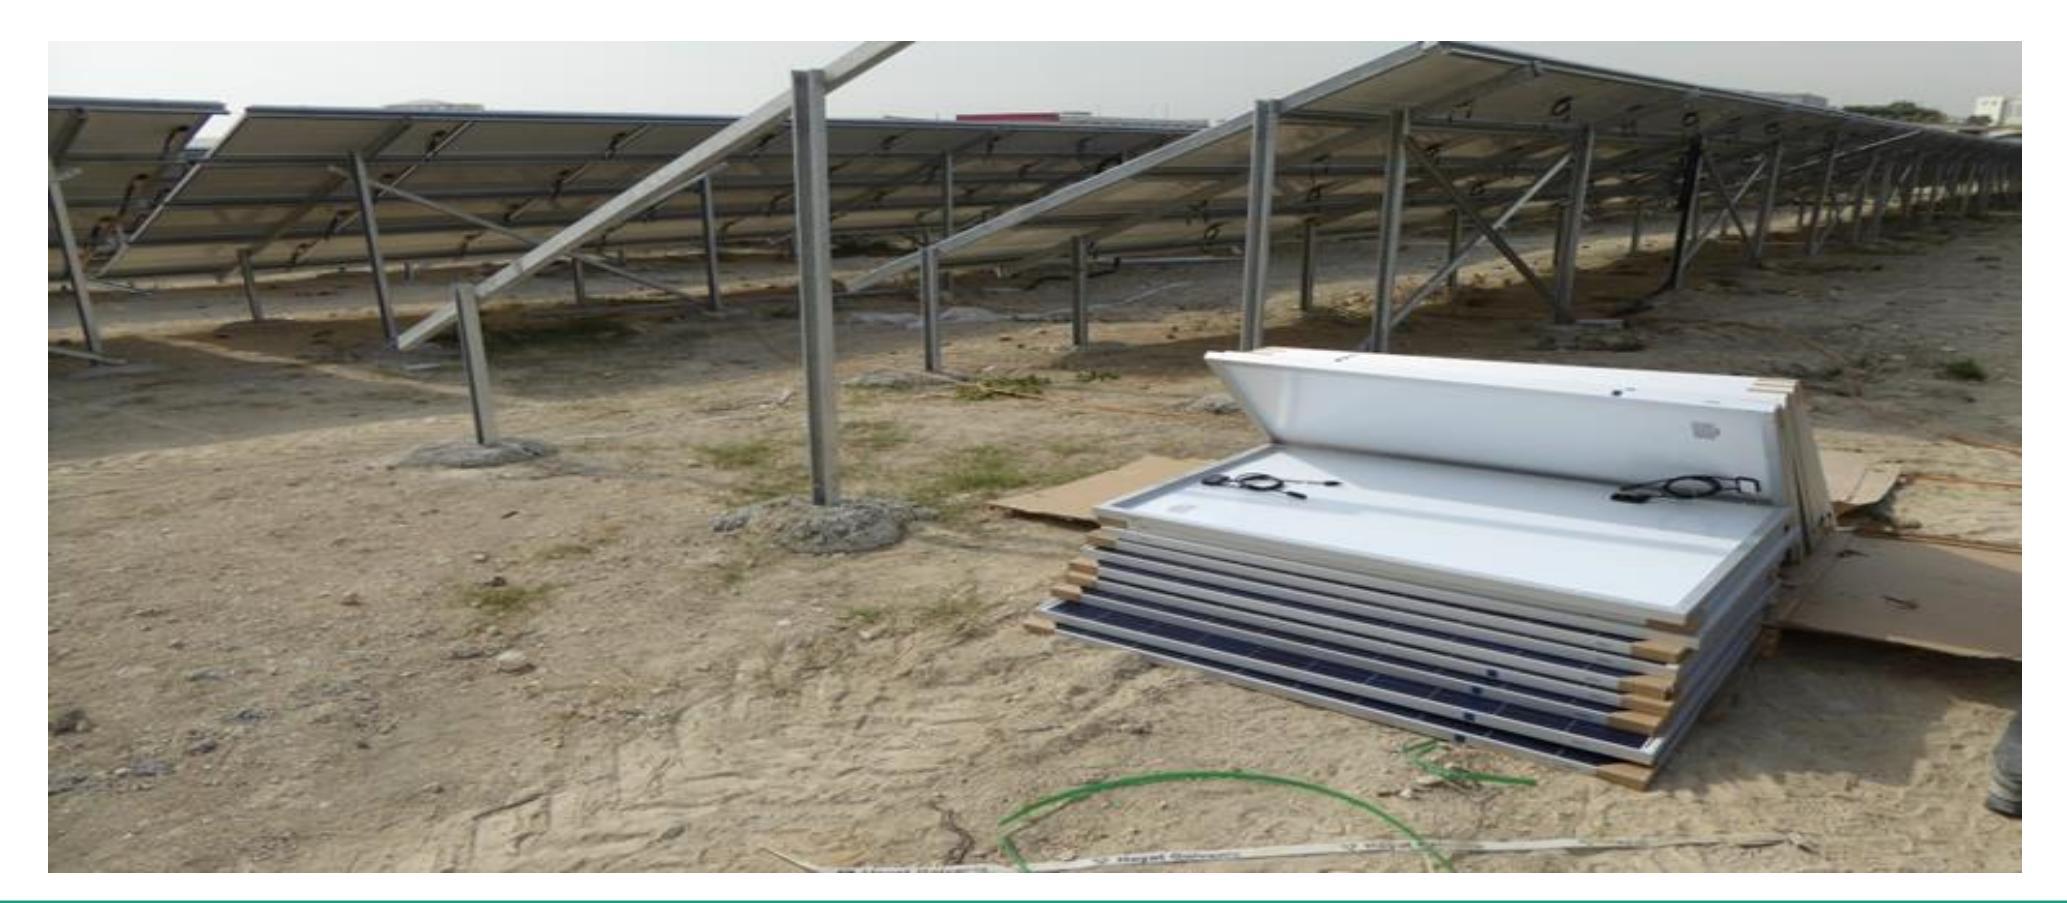
Unprofessional handling of the solar modules during their installation

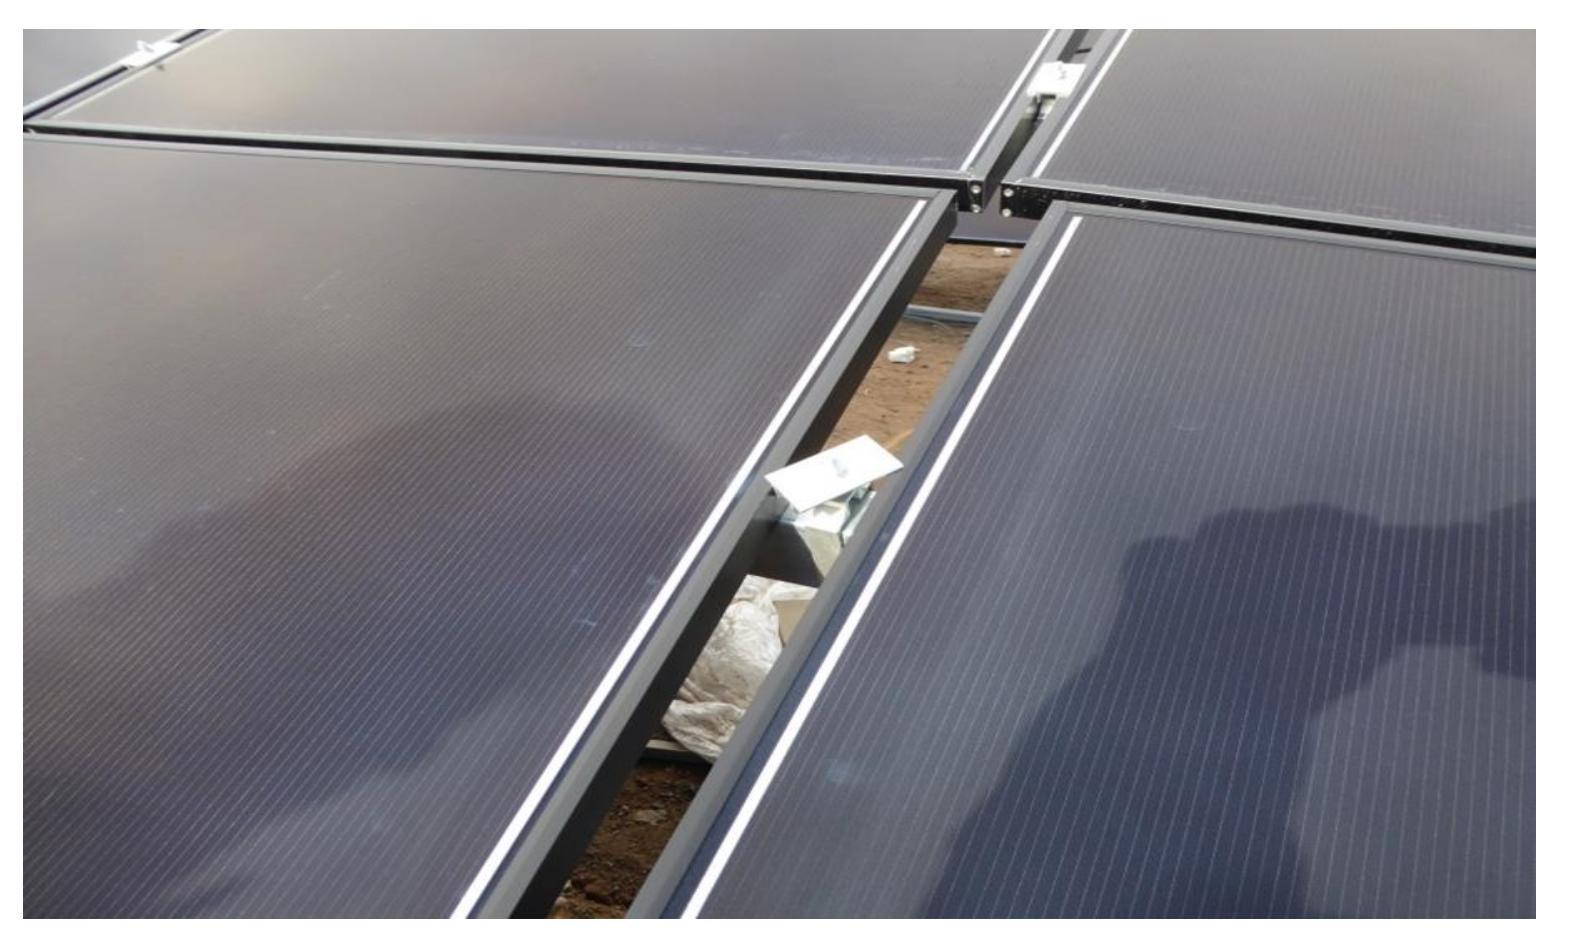
Unprofessional Mounting of the PV Modules

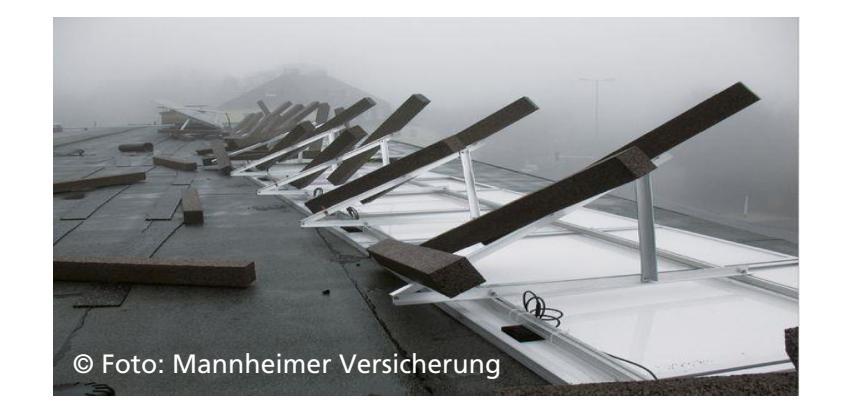
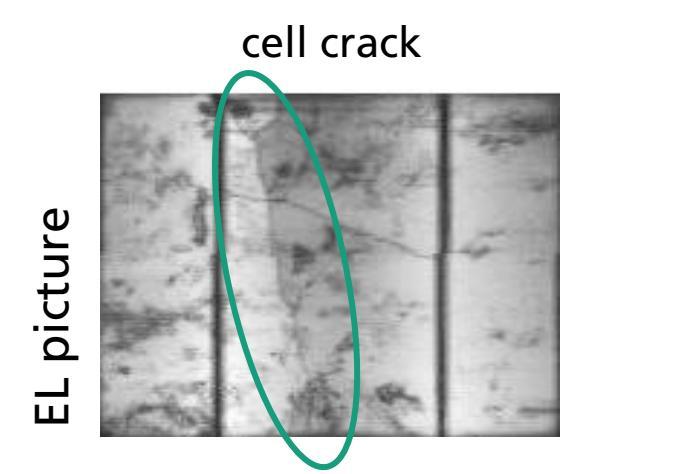
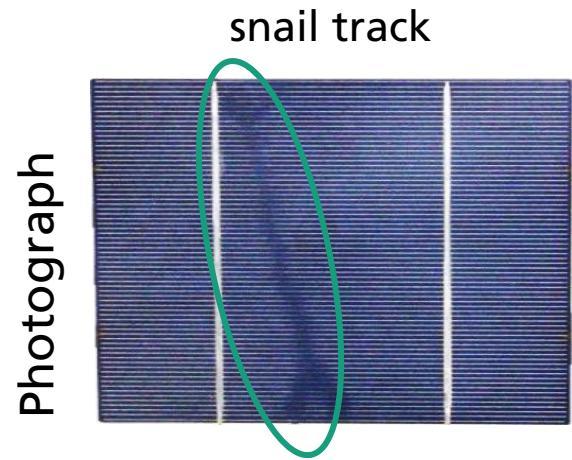
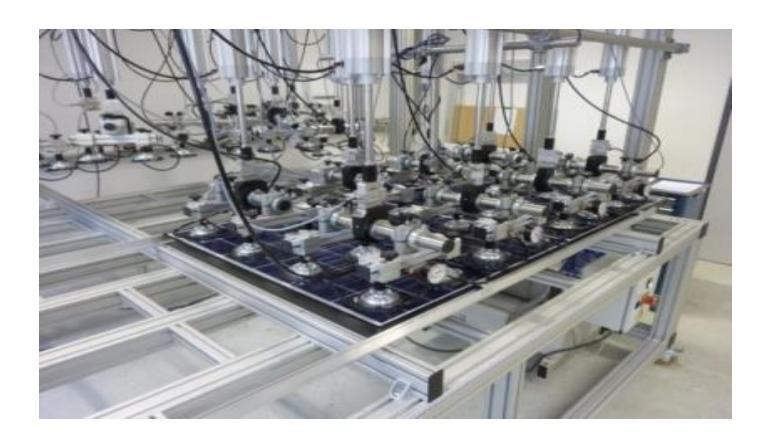
Quality Assurance for PV Modules Wind and Thunderstorm Damages

- More than 40% of claim expenses are due to mechanical weakness and insufficient lightning protection [1]
- Our experience: More than half of the failure analysis projects are directly or indirectly related to cell cracks

> Mechanical testing of module type and mounting structure ensures compability of the component

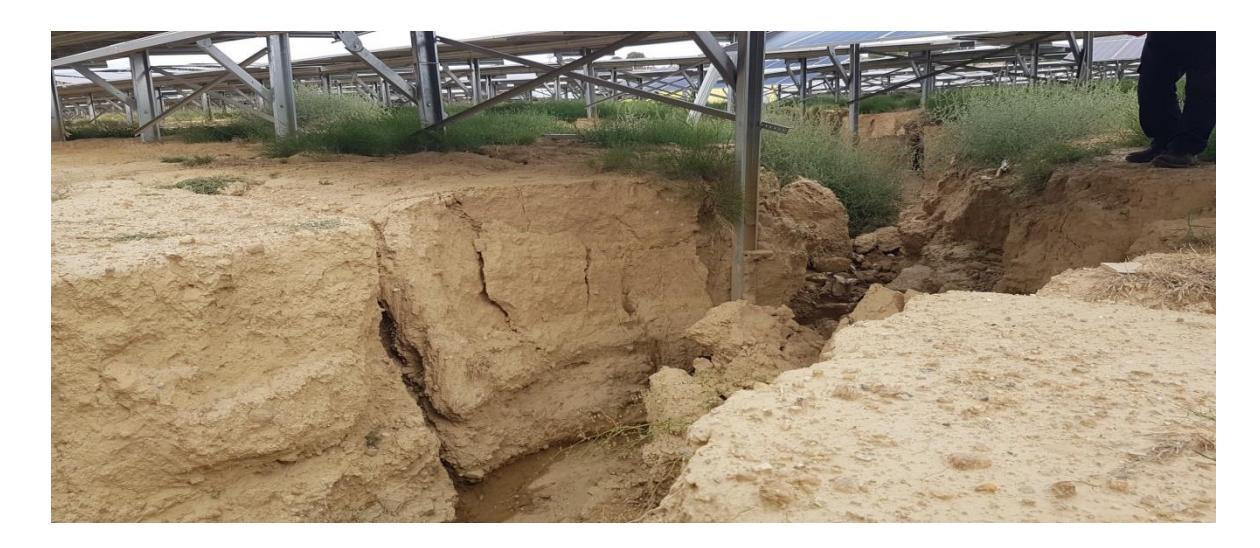
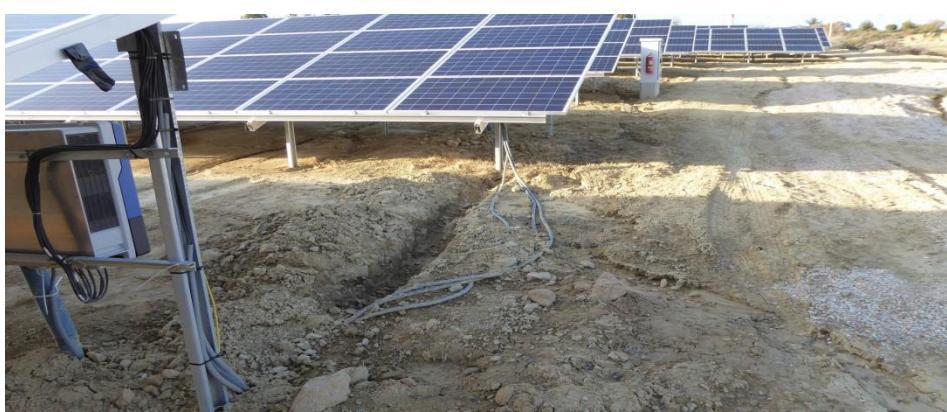
- Helps to detects installation errors very early
- allows to correct this failures

Deviations from the state of the art could be eliminated even before the final acceptance test

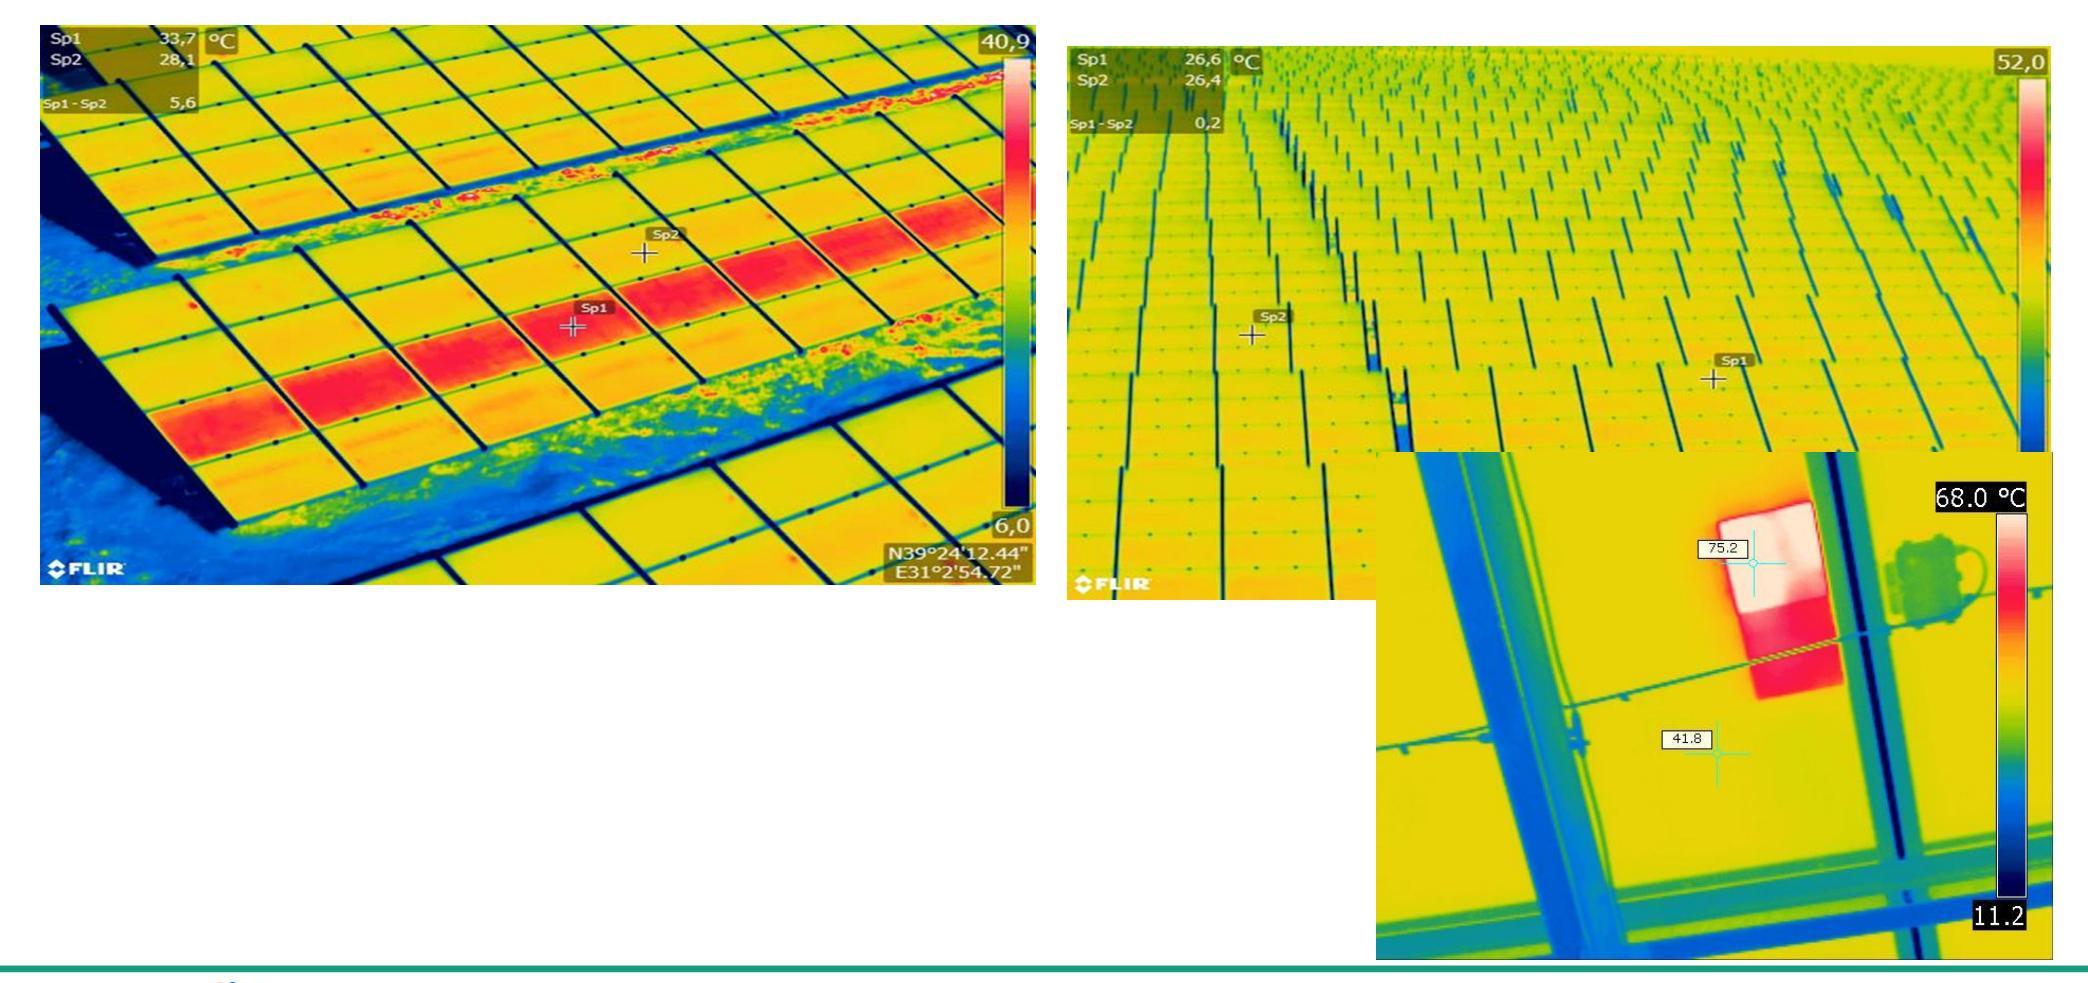
With infrared images it is possible to identify defective modules very efficiently

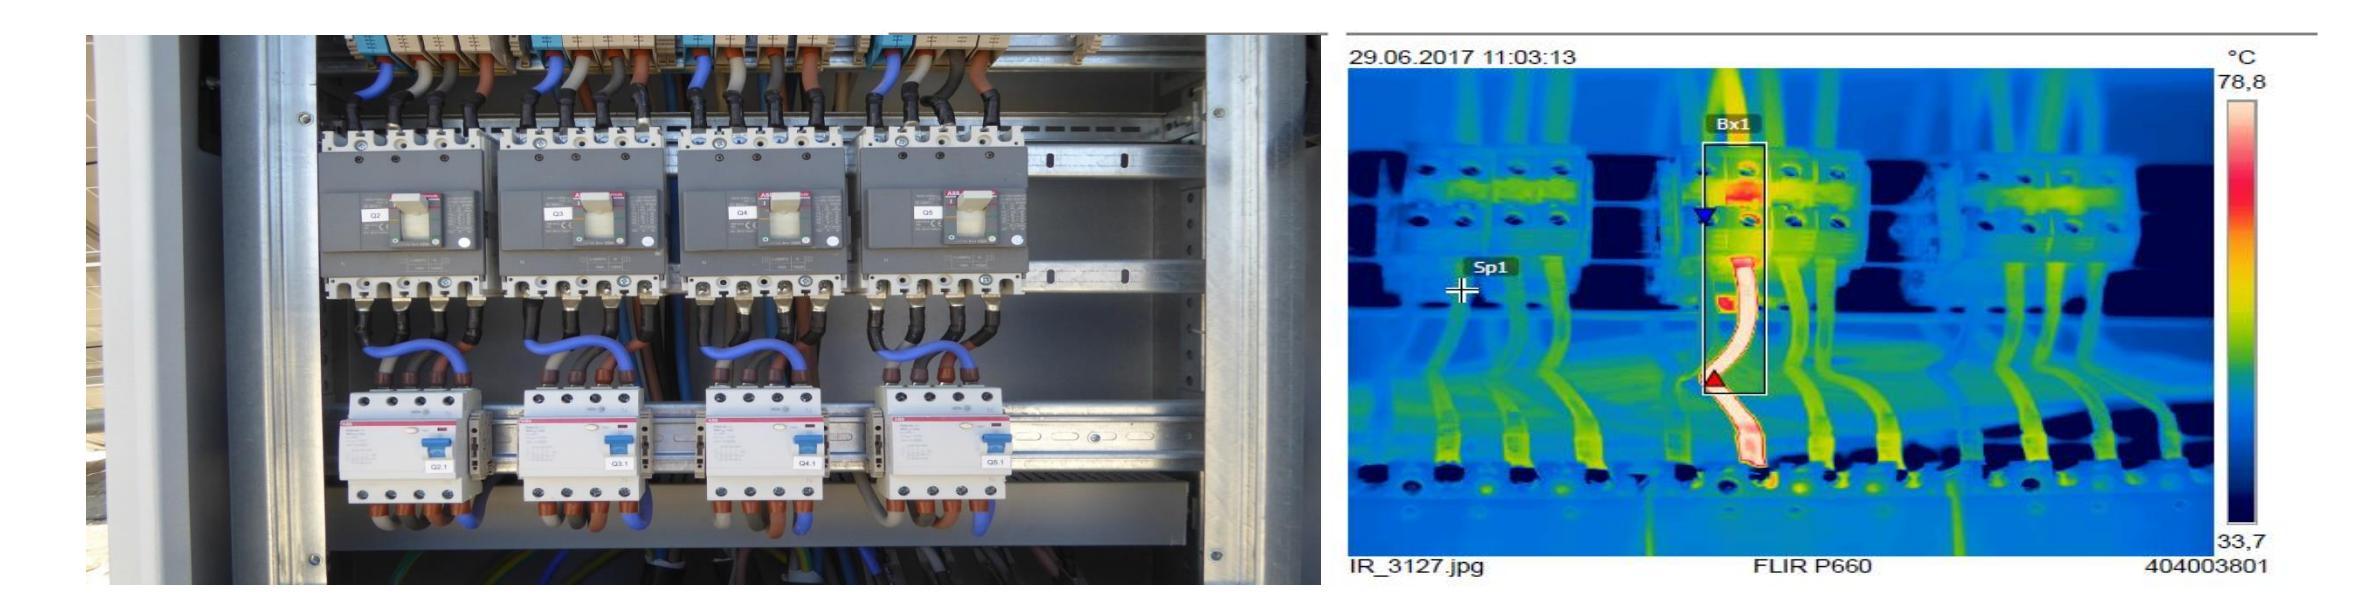
With infrared images it is also possible to identify faults in combiner boxes

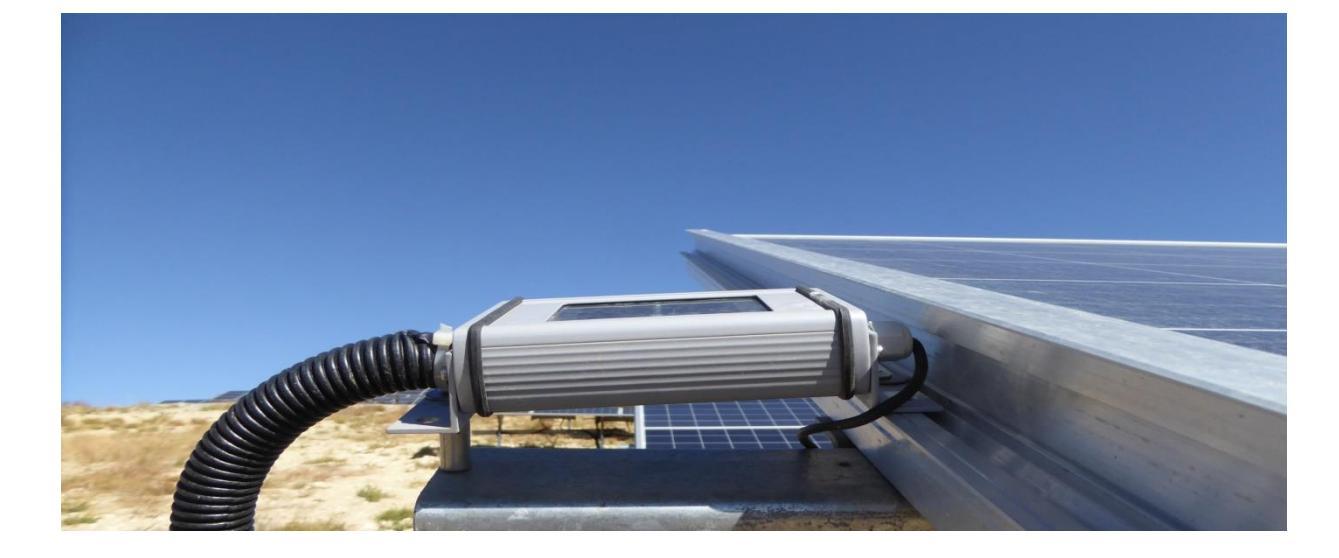
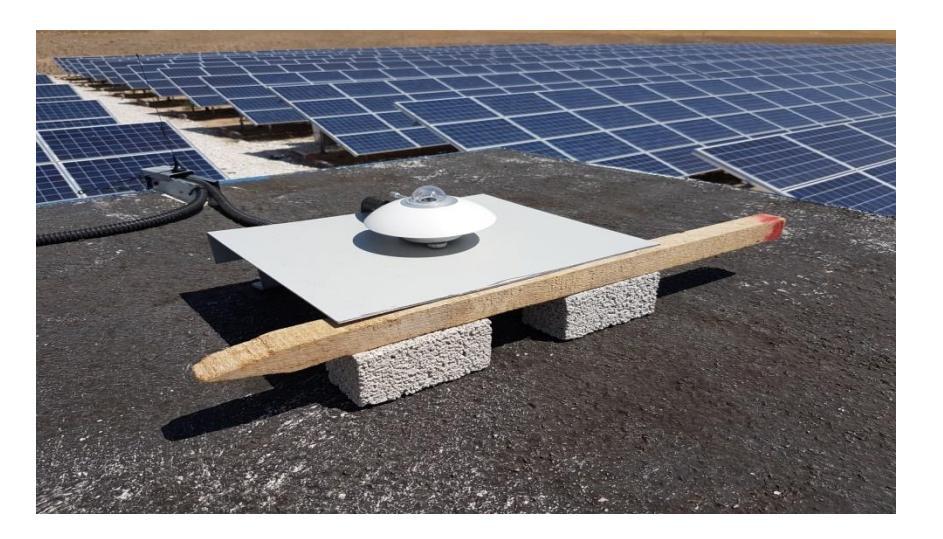
- The greatest weakness in all of the PV Power Plants Plants we investigated is the non-existent or incomplete monitoring
- Incorrect installation of irradiation sensors

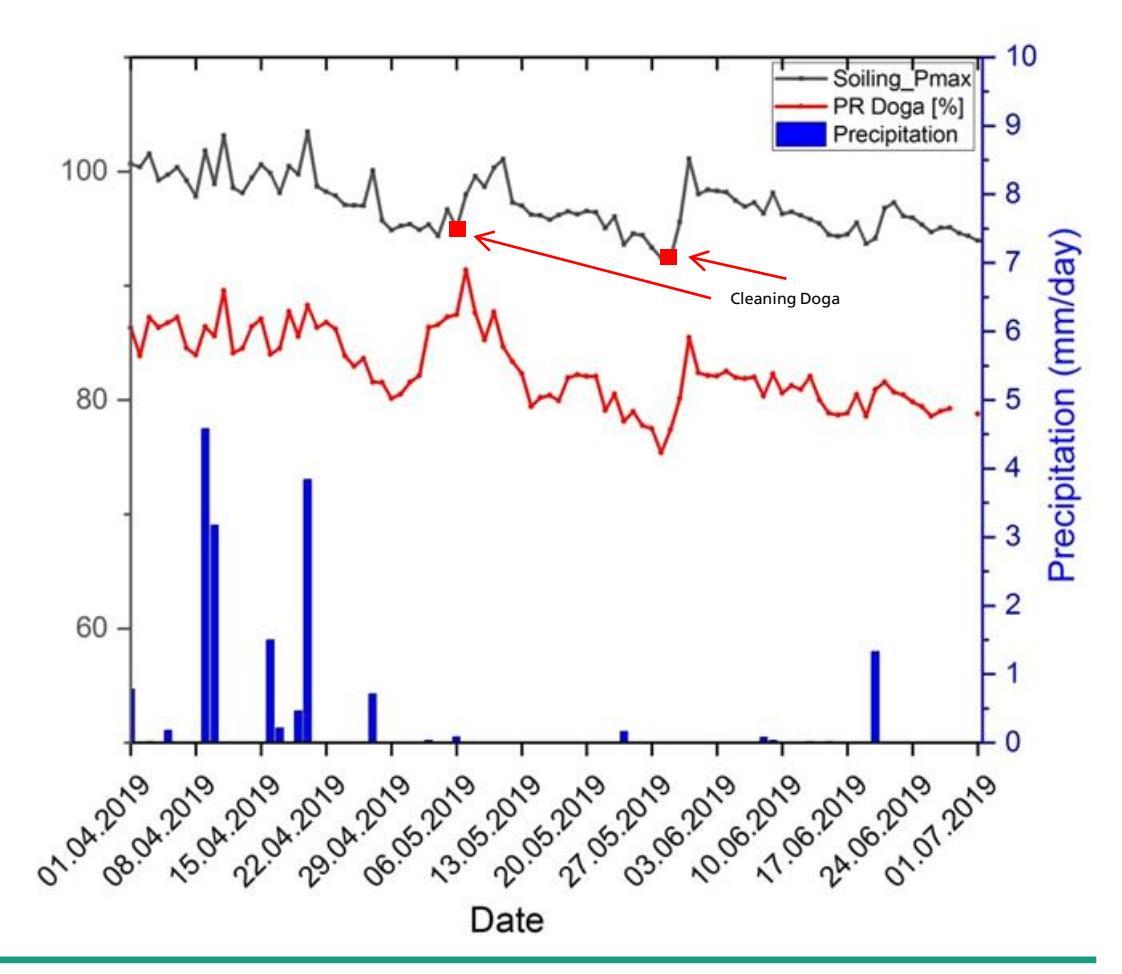
Correlation between soiling and Performance

The effects of cleaning are clearly visible

the cleaning of the modules can be carried out in a controlled procedure
